Manhole Inspection Summary

Manhole # S23AA1015MH

Insp Date: **6/25/07 2:36 PM**

Location Address: **ASH ST**

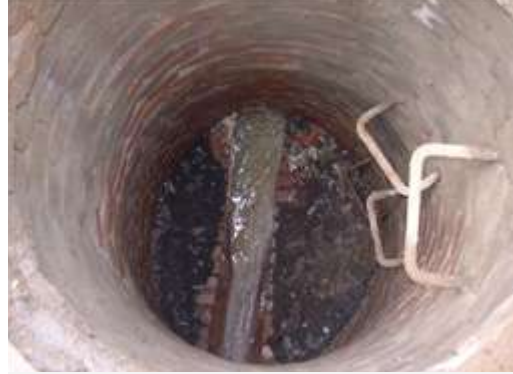
Top View

Corroded steps. Evidence of surcharge - Bench debris

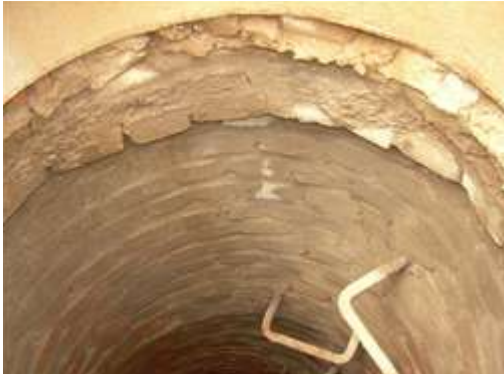
Defect

Frame leaks. Adjustment deterioration and infiltration. Corbel and Barrel infiltration.

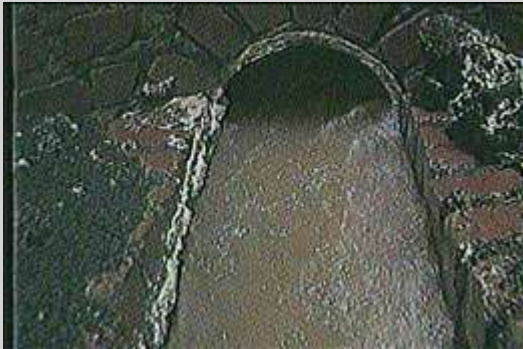
10 in. Circular Gravity Sewer Pipe Out @ 12 O'Clock

Barrel deterioration and infiltration. Bench and Channel deterioration.

Infiltration: **Evidence** Pipe Seal Cond: **Cracked**

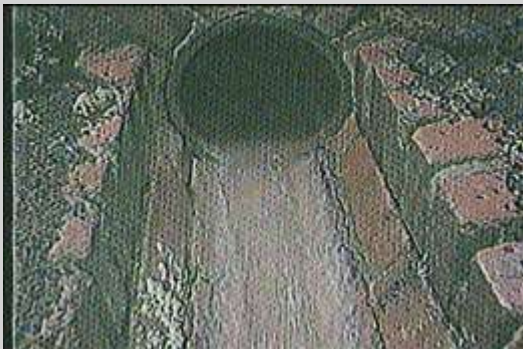
8 in. Circular Gravity Sewer Pipe In @ 6 O'Clock

Barrel deterioration and infiltration. Bench and Channel deterioration.

Infiltration: **Evidence** Pipe Seal Cond: **Cracked**
